**What Micro Serialized Firing Pins  
Can Add to Firearm Identification  
in Forensic Science:  
How Viable are Micro-Marked  
Firing Pin Impressions as  
Evidence?**

**David Howitt, PhD, Frederic A. Tulleners, and Michael T. Beddow  
Forensic Science Graduate Group  
University of California, Davis**

**Funded by the California Policy Research Center  
University of California**

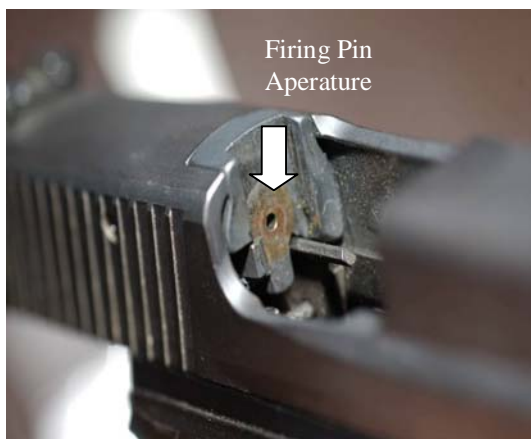
Figure 3

The radial barcode structures also showed extreme wear and degradation. First noted was obliteration of the bar code structures near the tip of the firing pin by the firing pin aperture. Enough size difference between the diameter of the firing pin and the diameter of the firing pin aperture (*Figure 3*) was present to allow the firing pin to move from side to side while at full extension during firing. The
